HEAT EXCHANGER CORROSION TESTS. PHASE
II

Oscar Oldberg

Army Mobility Equipment Research and
Development Center
Fort Belvoir, Virginia

July 1973

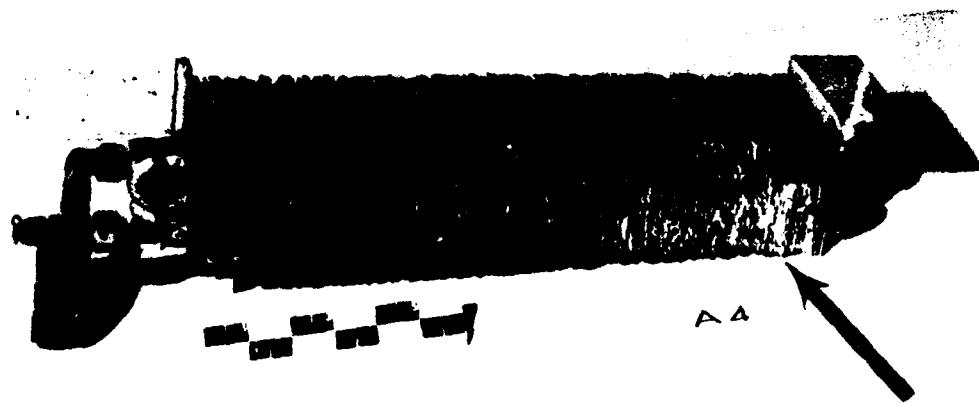
Figure 3. Condenser A4 Showing White Oxide Coating

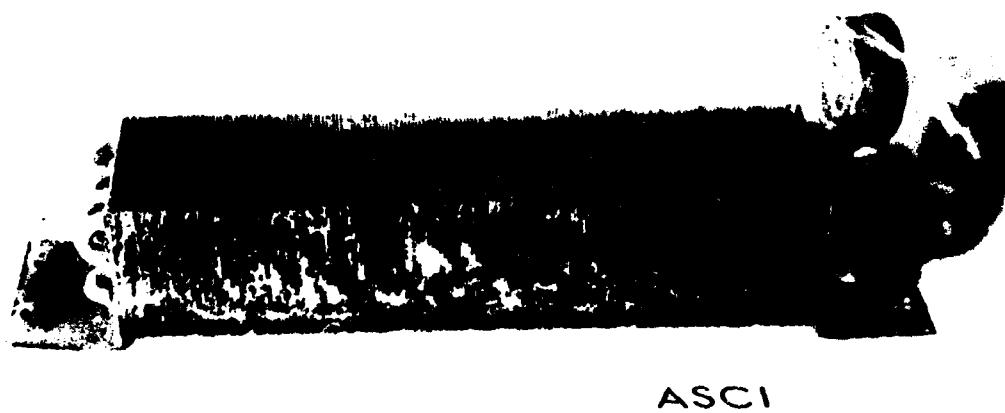
Figure 5. Condenser ASCI Showing Green, Orange, and White Deposits of Aluminum Oxide.
